Problems, Remedies & Preventive Measures

Drywall Construction

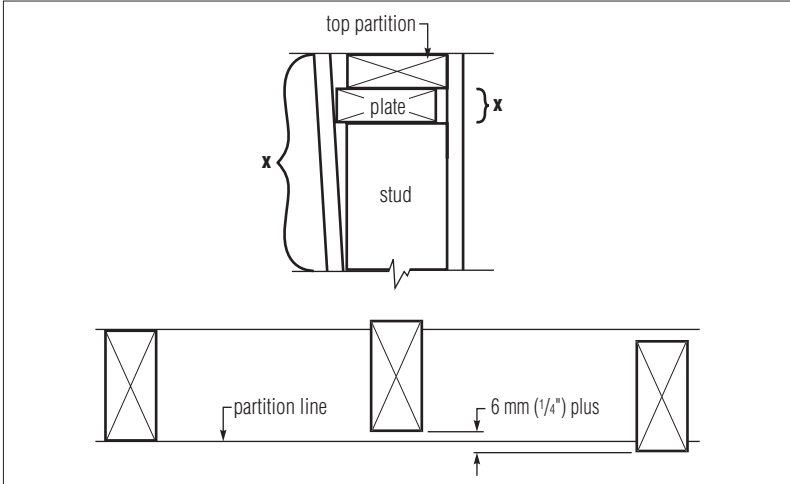
Fig. 10

Cause: Due to misaligned top plate and stud, hammering at points "X" (Fig. 10) as panels are applied on both sides of partition will probably result in nailheads puncturing paper or cracking board. Framing members more than 6 mm (1/4") out of alignment with adjacent members make it difficult to bring panels into firm contact with all nailing surfaces.

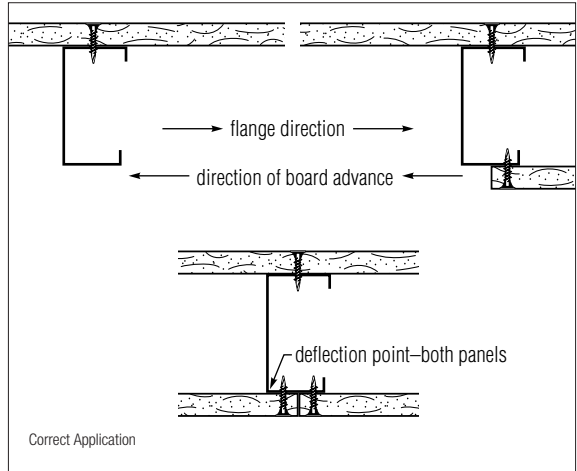
Fig. 13

Cause: Improper placement of steel studs or advancing in the wrong direction when installing panels can cause misalignment of panel edges and give the appearance of ridging when finished.

Prevention: Install steel studs with all flanges pointed in the same direction. Then install panels by advancing in the direction opposite the flange direction (Fig. 13).
